# GreenRoot News

## A story of a hidden canal

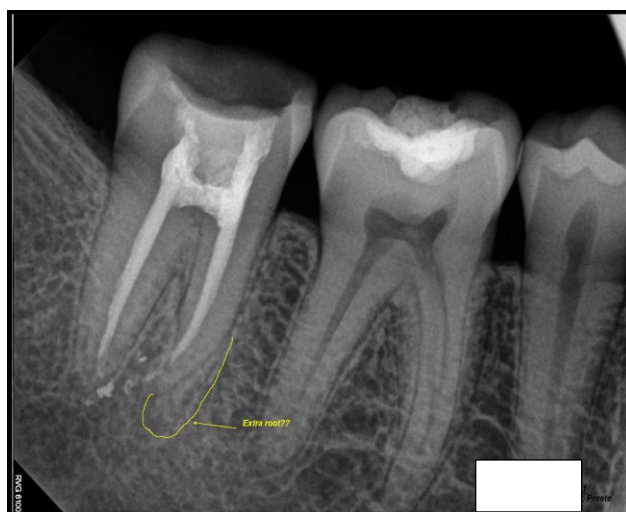
Fig. 1: Pre-Op PA showing the presence of possible separate mesial root.

Upon initial radiographic exam, one of the angled periapical radiographs showed a suspicious extra PDL indicating a possibility of extra mesial root (Fig.1). However, it was not very clear on the other pre-operative radiographs.

Based on my initial testing, #31 was diagnosed with failed endodontic therapy with symptomatic apical periodontitis. I also suspected a possible vertical root fracture &/ missed root canal anatomy. During this visit, she was also educated about the benefits of using a night guard & stressed on having one fabricated by her Dentist. I decided to take the Cone Beam CT (CBCT) after all the thermafil carriers were taken off to prevent any false positive result

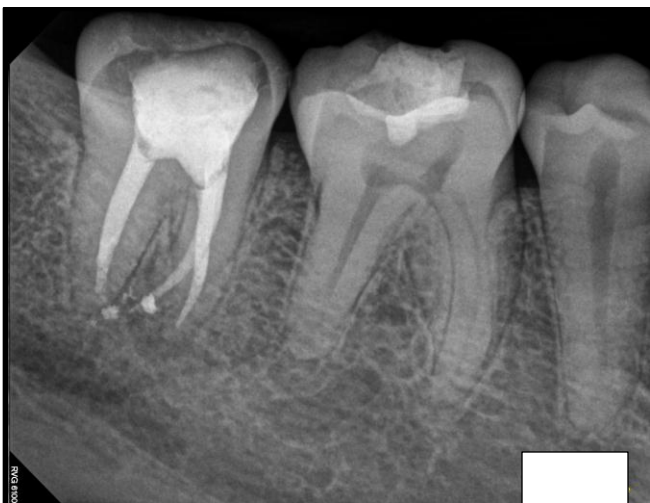
Fig. 5: Post-Op X-ray

Obturation was completed after one week & the access was restored with Flurocore under rubber dam isolation (Figs. 4 & 5).

Patient was returned back to her general dentist for a permanent crown. A recommendation was given for fabrication of a night guard.
