# INVASIVE CERVICAL RESORPTION

## A Case Report

## CASE REPORT

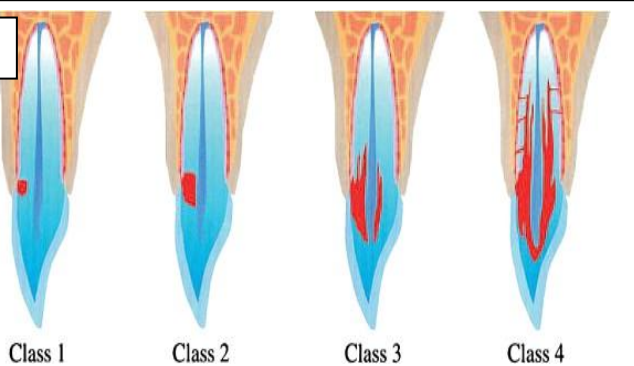
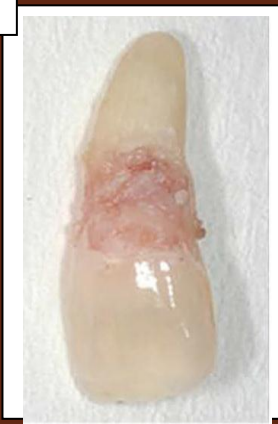
Heithersay classified ECR according to the extent of the lesion within the tooth (Fig.1 A):

**Class 1:** A small invasive resorptive lesion near the cervical area with shallow penetration into dentin;

**Class 2:** A well-defined invasive resorptive lesion that has penetrated close to the coronal pulp chamber but shows little or no extension into radicular dentin;

**Class 3:** A deeper invasion of dentin by resorbing tissue, not only involving the coronal dentin but also extending at least to the coronal third of the root.;

**Class 4:** A large invasive resorptive process that has extended beyond the coronal third of the root canal.

**While classes 1-3 are treatable, Class IV defects in general needs extraction due to poor prognosis**

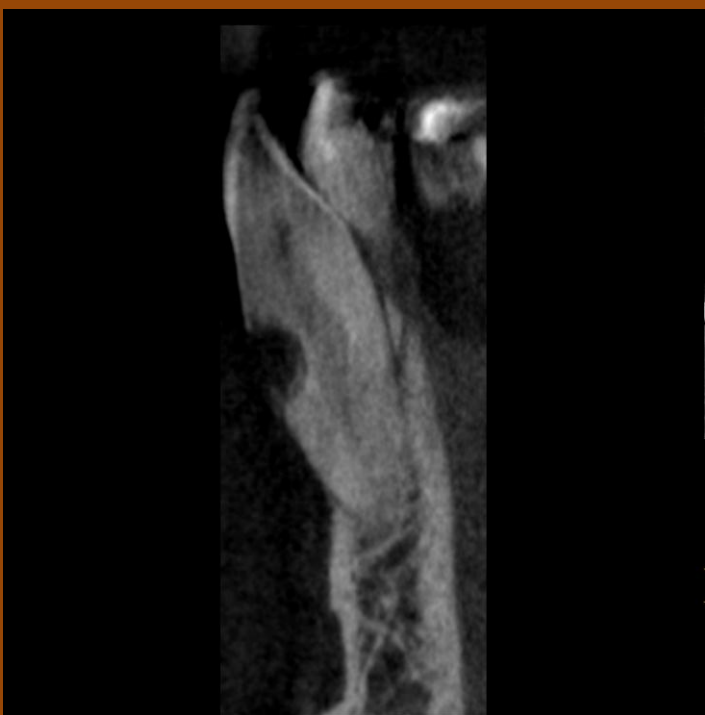
Fig. 3: CBCT showing the extent of resorption defect.

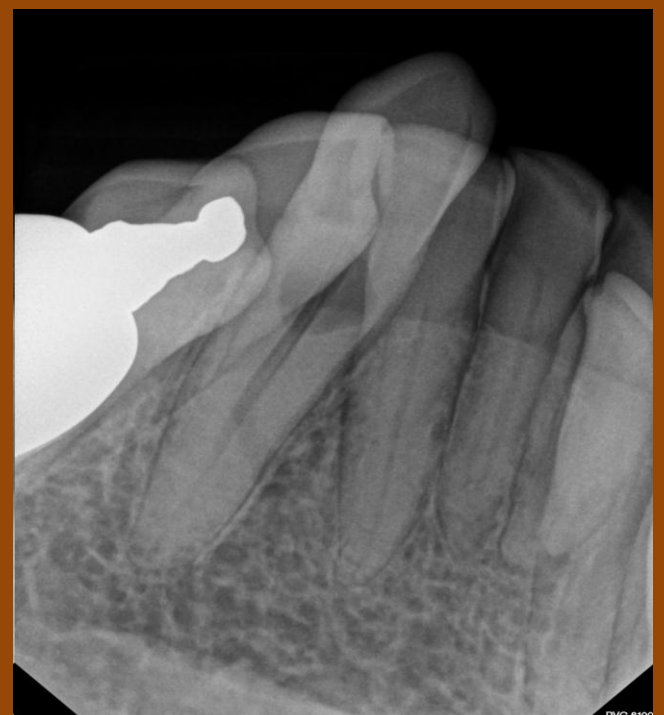
Fig.2: Pre-Op x-ray. Note the root canal outline within the defect indicating the resorption is external

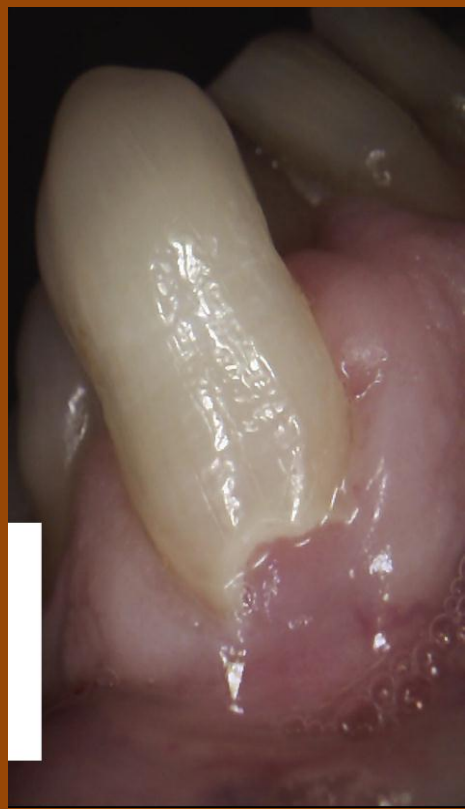
#27 responded within normal limits to cold. It was percussion negative but the tender of palpation especially on the coronal third. The coronal gingival margin was edematous & bled on probing. I was able to probe the resorption cavity with the explorer.

Fig. 4: Intra oral picture

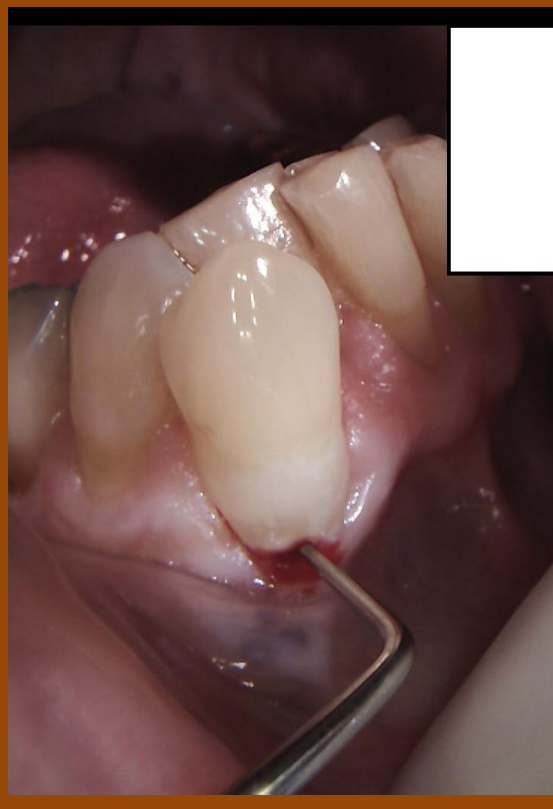
Fig. 5: Probing the defect

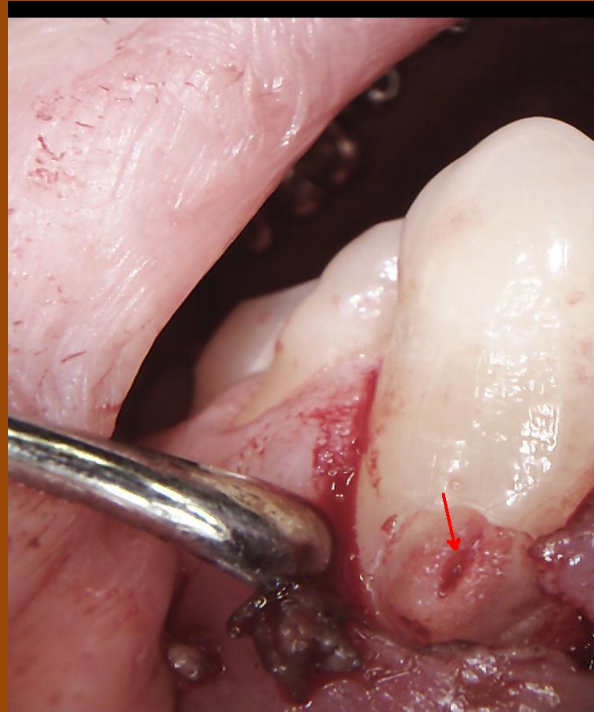
Fig. 6: Surgical exposure of the defect. Note the pulpal exposure.

A full-thickness periosteal flap was raised to allow complete access and removal of the ECR lesion from the root. All the granulomatous tissue from the adjacent periodontium was curetted away to sever the blood supply to the resorbing cells, thereby decreasing the chances of recurrence. It was then treated with Trichloroacetic acid to cause the coagulation necrosis of the resorptive tissue. The root defect was restored with Geristore. Due to large & visible pulpal exposure upon flap retraction, non-surgical RCT was performed on #27.

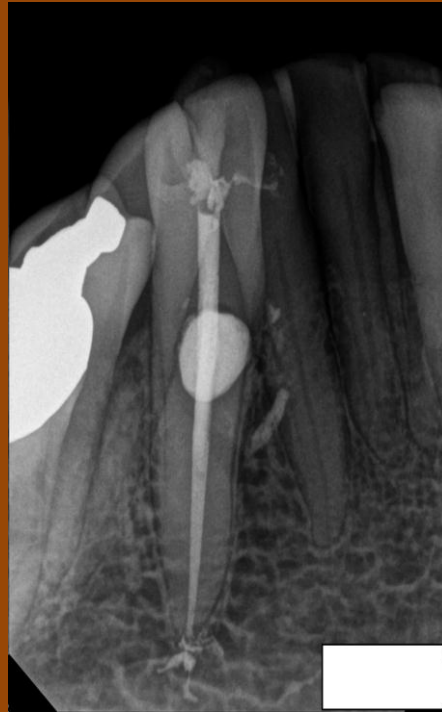
Fig. 7: Post Op x-ray

Post-op healing was uneventful and healed within normal limits.

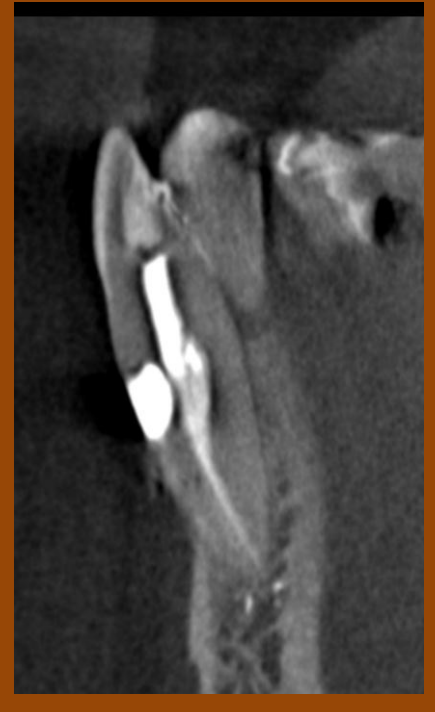
Fig.8: Post Op CBCT view
